THE PLUMB LINE *SPRING*

Water Heater Edition

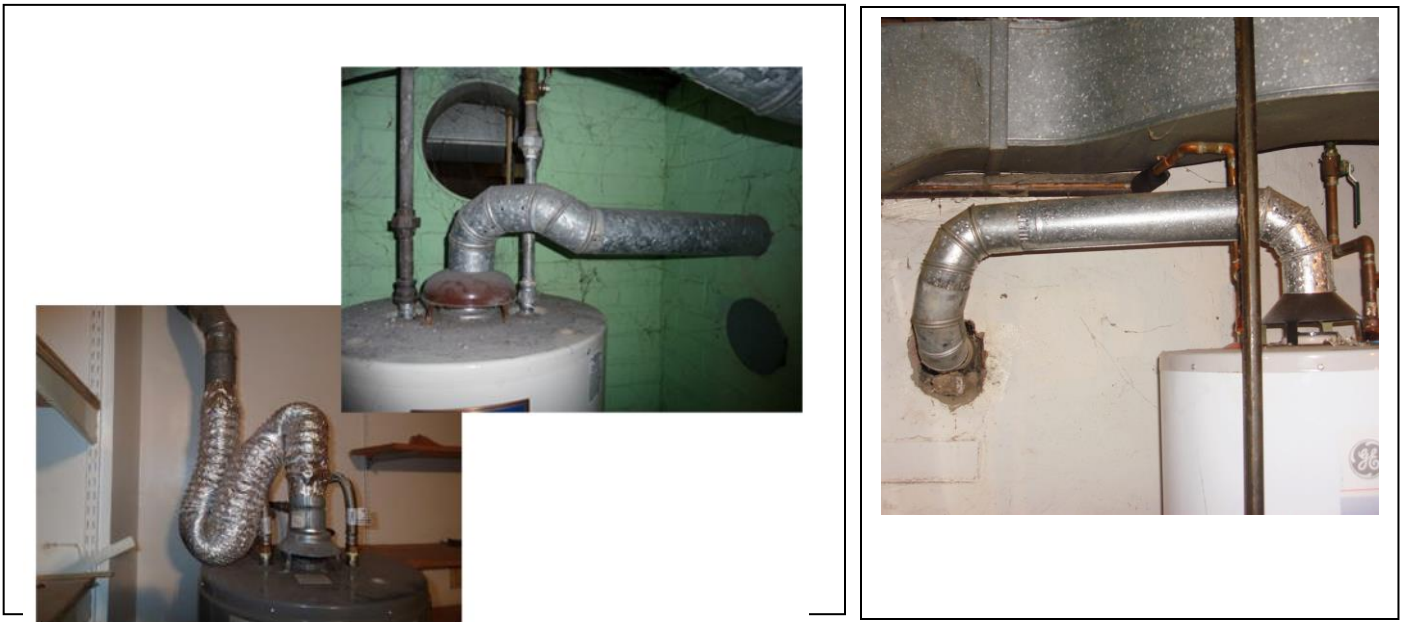
Venting Tales

One such tale is that when roofers came to replace the roof, they inadvertently hit the vent and knocked it loose. This caused the vent to terminate in the attic. In at least one case this has led to a fatality. This is not something we as plumbers can fix, however it is our responsibility to make sure the venting is up to code when we replace a water heater. Usually this is as simple as climbing into the attic and making sure the vent is intact. **Do not allow a gas appliance to be operated with out proper venting.** If a homeowner tells you they will take care of it, do not connect gas to the appliance and contact either the local inspector or your state inspector. Another Scary tale, a plumber changed out two tank type 50gal. cat. I heaters to one 199,000btu category IV tankless heater. The plumber terminated the plastic sch40 vent in the existing type B vent. (The code violations for this alone are too numerous for this article.) The homeowner, of course, had a wet ceiling and called the plumber back. This time the plumber connected the Cat.IV vent to the plumbing venting system. Again, the code violations are too numerous to note in this article. Let's just say that obviously a gas vent terminating in a plumbing vent is of great concern as a health risk and dangerous situation.
